TN 1968-7

Haystack Antenna Reflector Surface Improvement Program D. G. Stuart

29 January 1968

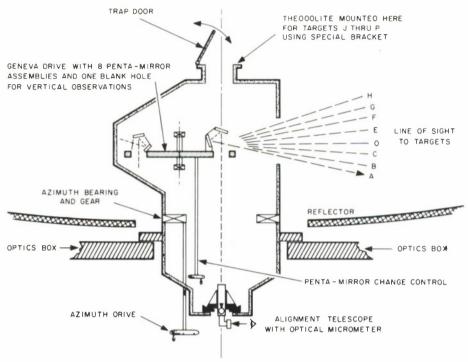
Fig. 5. Schematic of optic probe.

The results obtained showed that <u>all</u> of the penta-mirror assemblies were in error, some by small amounts, and others up to almost one minute of arc. The worst penta-mirrors were disassembled and the reason for the errors became clear. Corrosion was found on the mirror support buttons. Only a few micro-inches of corrosive buildup are necessary on these buttons to eonsiderably alter the value of the penta-mirror angle. During eonstruction of the reflector, in the winter of 1963-1964, some problems were experienced with water seeping through the radome joints from melting snow and ice. Considerable water was present around the optical probe and humidity was quite high. The presence of such large amounts of moisture is believed responsible for the corrosion in the penta-mirror assemblies.

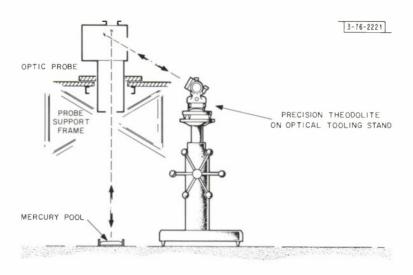
Fig. 6. Autocollimation setup for calibrating optic probe in a room temperature-controlled to $68^{\circ} \pm 1^{\circ}F$.

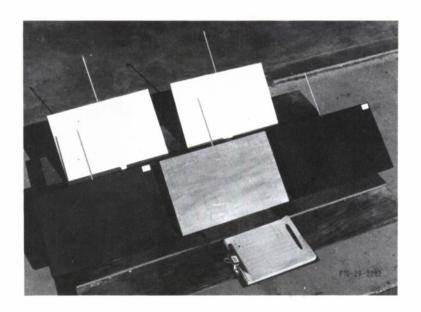
Fig. 10. Test setup for selecting splice plate paint.

In connection with the analytical study effort, Simpson Gumpertz & Heger ran an analysis of a thermal model of the reflector on a 7094 computer. The results of this computer run indicated that the only structural member in the reflector that had any serious effect on surface quality, was the splice plate (Fig. 9). In a thermal study by Dynatech, it was shown that the various members of the reflector structure had widely varying thermal time constants (Table I). The value of the time constant for the splice plate was calculated to be about 4 hours, while the time constant for the surface panels was only a very few minutes. It was this difference in time constants between the panels and splice plate that caused the large amount of warping of the surface observed under the influence of thermal-time gradients. This accounted for the large change in rms from the noontime condition to the midnight condition.

During the study several ideas for desensitizing the response of the surface to thermal influences were explored. Meanwhile, in an attempt to reduce this thermal effect tests were conducted to choose the most effective splice plate paint (Fig. 10). Flat back krylon was chosen and the splice plate was painted on both front and rear surfaces (Fig. 11). Subsequent sets of readings showed the noontime rms was reduced to about 0.045 inch, while the midnight rms remained at about 0.035 inch. It was concluded from these observations that the greater part of the 0.035-inch rms midnight value was due to built-in errors stemming from errors in the optical probe. The change in rms for the two thermal conditions began to be consistent with goals desired in readjusting the reflector surface.

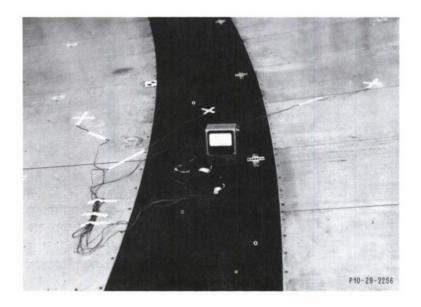
Fig. 11. Splice plate after painting showing differential temperature measuring equipment and typical optical targets.

The most significant result of the thermal model computer run was the revelation that the splice plate time constant was solely responsible for the thermal deviations of the surface. Previously it was thought that some of the other heavy back-up structure members, which had also been shown by Dynatech to have large time constants, were contributing to these surface deformations. The fact that the time constant of the splice plate alone was responsible considerably simplified the problem of dealing with this thermal response.

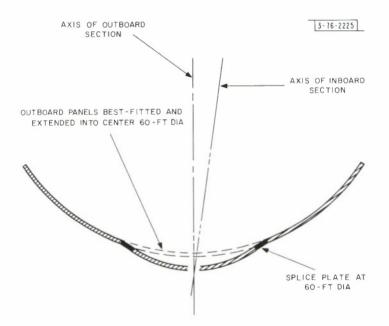
Fig. 13. Exaggerated sketch of reflector shape.

Plots of the deviations from the best-fit paraboloid resulting from the series of measurements taken showed some interesting characteristics. The shape of the reflector surface could be visualized as two separate reflectors separated by the splice plate (Fig. 13). The inner reflector, or inner 60-foot diameter, was deeper in curvature than the best-fit paraboloid, and had the largest deviations from the best-fit. The outer portion of the reflector more nearly matched the curvature of the best-fit paraboloid. In addition, the inner 60-foot diameter appeared slightly tilted with respect to the outer portion of the reflector. Rms calculations were made for both the inner 60-foot portion and the outer portion, as separate entities. After inspection of these results, a best-fit was made to the outer portion of the reflector and then extrapolated toward the center of the reflector. Values were then assumed for the center 60-foot portion, assuming reasonable tolerances for adjusting to the contour of the extrapolated best-fit parabola. The resultant rms calculated for the whole reflector was most encouraging, and from this was derived the idea of adjusting only the center 60-foot diameter to the paraboloid which best fit the outer portion of the reflector. This in effect increased the errors in the center 60-foot diameter while it reduced the errors in the outer panels. The advantage of this approach was the considerable reduction in area that must be considered for readjustment. The inner section was only one-fourth of the area of the reflector and therefore required only one-fourth of the number of adjustments. In addition, the center 60-foot diameter was an easier area in which to perform adjustments than was the outer section of the net access system.

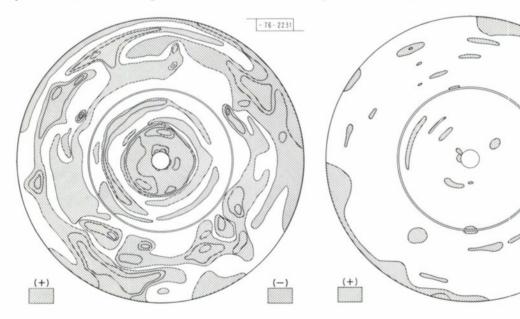
Fig. 20. Deviations from best-fit paraboloid before adjustment (rms = 0.037 ineh; contours of deviation at 0.025-inch intervals).

Fig. 21. Deviations from best-fit paraboloid after adjustment (rms = 0.017 inch; contours of deviation at 0.025-ineh intervals).

When the reflector was first considered for an adjustment program, the daytime rms of the best-fitting paraboloid was 0.055 inch. This was reduced during the study phase of the program, by the painting of the splice plate, to about 0.044 inch rms. The adjustment program then reduced these values to 0.017 inch rms for nighttime conditions, and, except for very extreme summer day conditions, the rms is not expected to exceed 0.025 inch for the sunny day condition (Figs. 20 and 21).

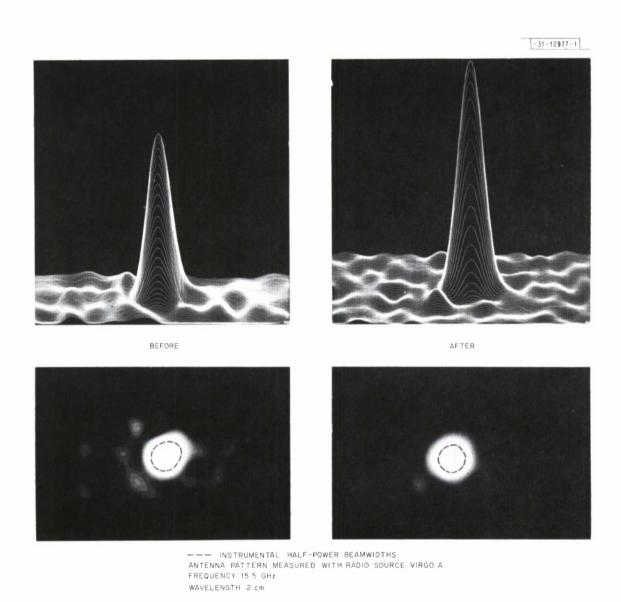
Fig. 22. Improvement in performance of Haystack antenna following Fall 1967 adjustments.

So far, a 1.5-db increase in gain has been observed at 15.5 GHz (Fig. 22). At 35 GHz, prior to the adjustment program, no defined beam was formed. After adjustment, pattern measurements made at 35 GHz show a well-defined beam with the highest side lobe 9 db down from the main beam (Figs. 23 and 24). These 35-GHz patterns were taken at the horizon and therefore suffer somewhat from the degradation of the surface due to gravity deflection near the horizon.
